**FEDERAL AVIATION ADMINISTRATION
AIRWORTHINESS DIRECTIVES
LARGE AIRCRAFT**

BIWEEKLY 2000-09

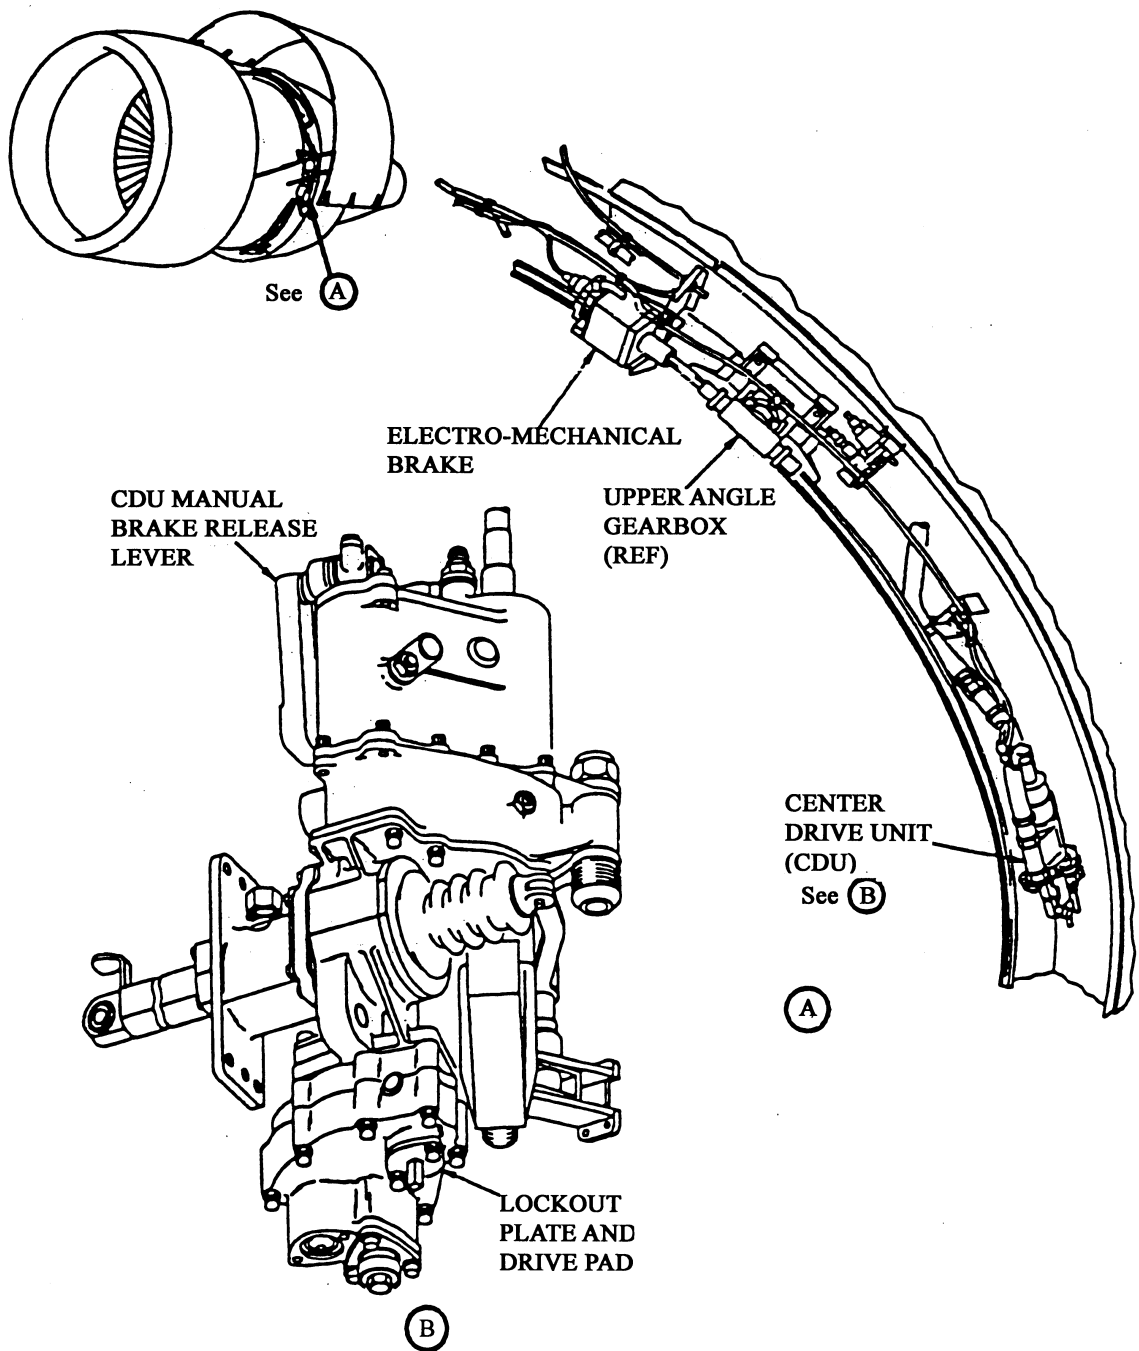
Figure 1

Electro-Mechanical Brake and CDU Cone Brake Torque Check

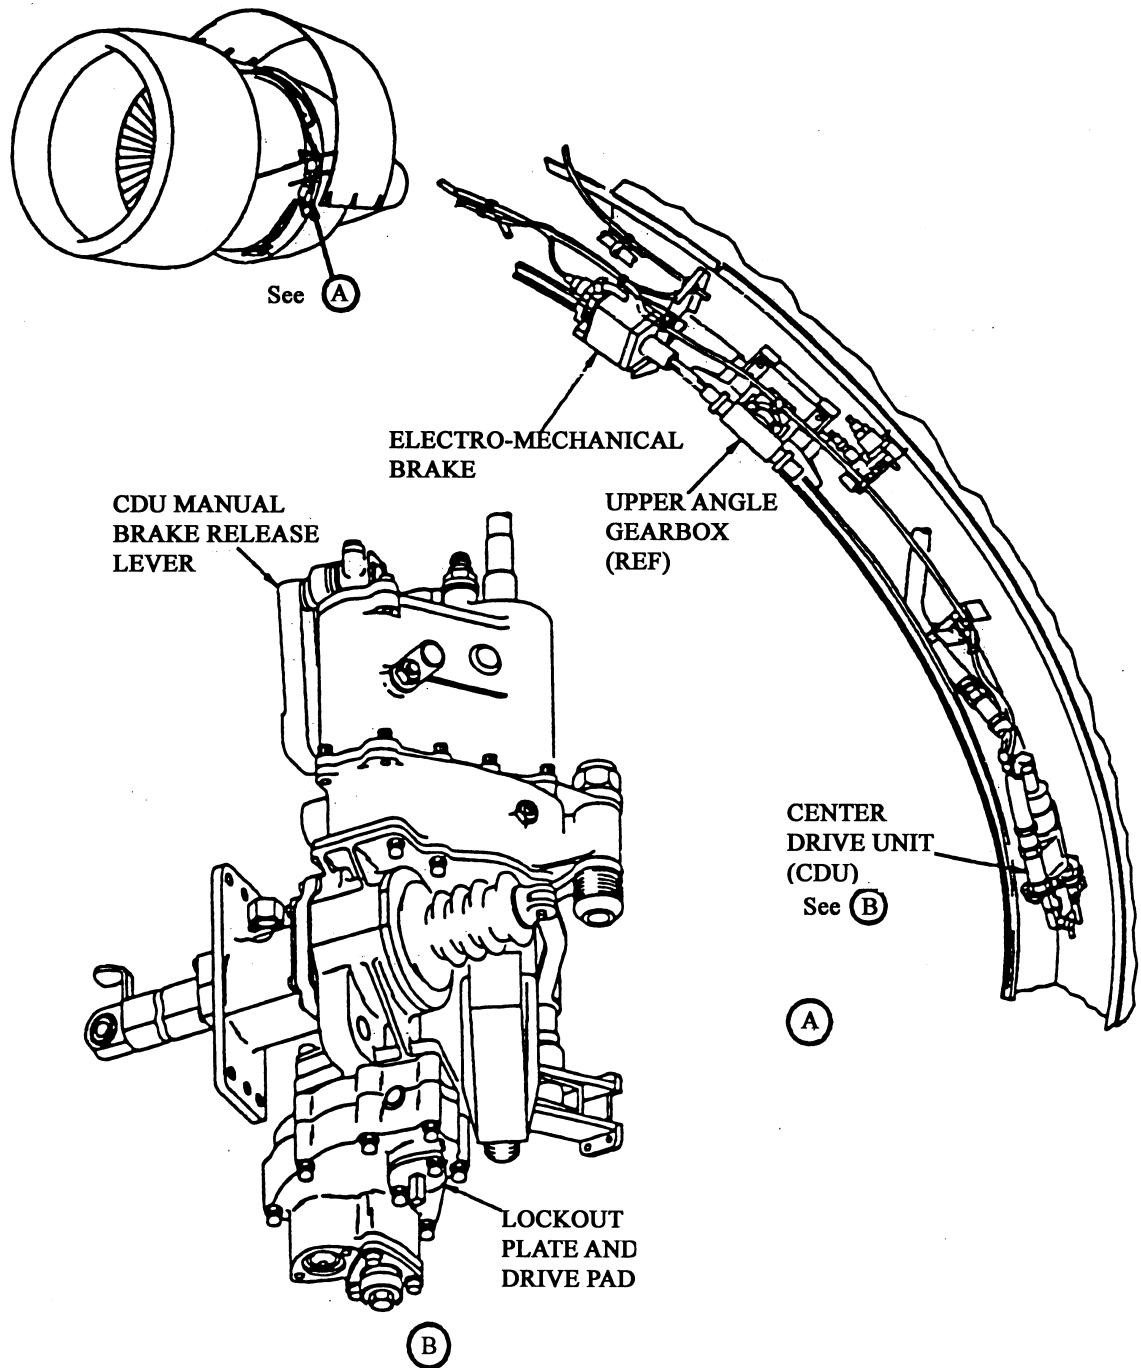
Figure 1

Electro-Mechanical Brake and CDU Cone Brake Torque Check
